Service Info

RIU 566425.H195 and 566283.01.H195

Assembly note

Design: Repair Insert Unit (RIU)

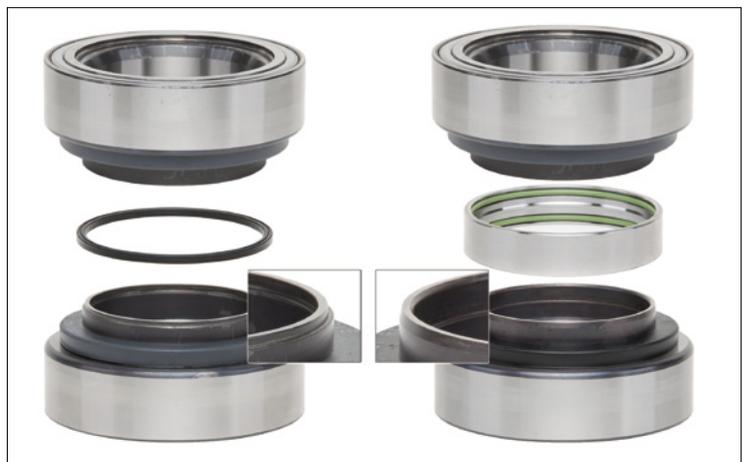
Image 1: The differences between the versions from FAG (left) and the OES (right)

Technical background: On the wheel bearings originally used, two sealing rings (O-rings) are located within a metal ring. These sealing rings are pushed over the two inner rings during assembly. On the repair solution from FAG, the sealing ring is an O-ring that is not held in place by a metal ring. Instead, the O-ring is placed between the two wheel bearing halves during assembly. This seal still has all of the properties related to its application and is simply a different design variant.
