# Repair of CFM56 #4R Bearings with Replacement of Components – Bearing Reconditioning

**Overhaul of the CFM56 #4R mainshaft engine bearing with replacement of components (cage, rollers, outer ring)**

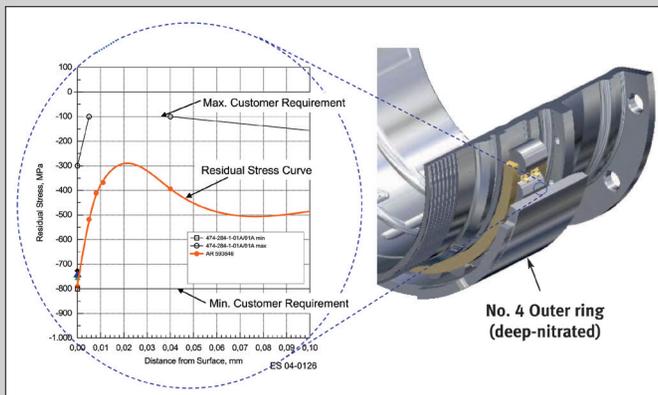
The original design included an outer ring made from M50 material. The initial improvement was to add a stress profile requirement for the raceway of the M50 outer ring. To further improve the reliability, the outer ring material was modified with nitrogen hardening and a specific stress profile (see *Figure 1*) for the raceway.

Figure 1. Residual stress profile for the raceway.

Any re-work of the outer ring raceway (honing, polishing) will change the stress profile and could lead to an out of limits condition, with the possible consequence of a reduced bearing reliability.

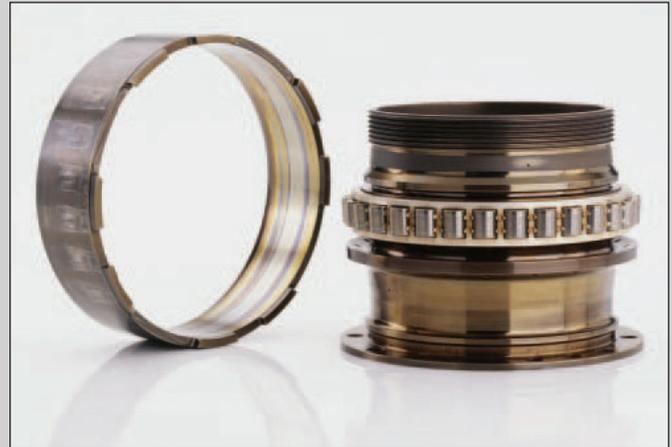
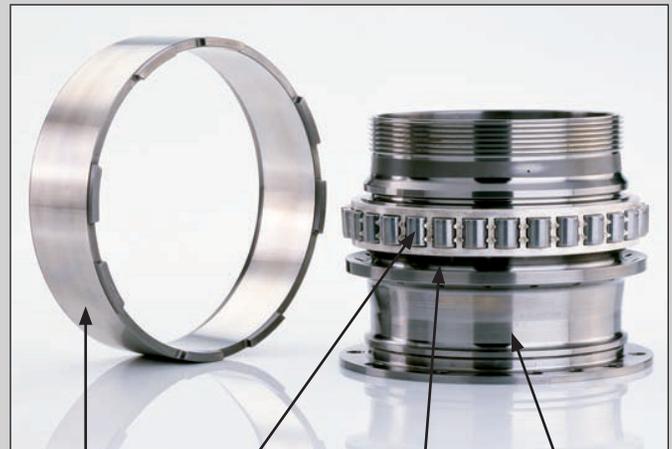
Figure 2. The following pictures illustrate the condition of the CFM56 #4R bearing assembly before and after repair.

**Outer ring:**  
Replaced with newly manufactured ring during repair

**Rollers:**  
Replaced with newly manufactured components during repair

**Cage:**  
Replaced with newly manufactured components during repair

**Inner ring:**  
Re-manufactured and re-inspected per SNECMA instructions
