Schaeffler Global Technology Solutions

Modal Analysis helps to increase Speed of Stretch Reducing Mill

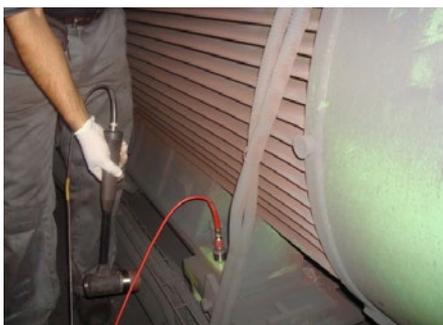
Sensor positions at support of the motor for bump test

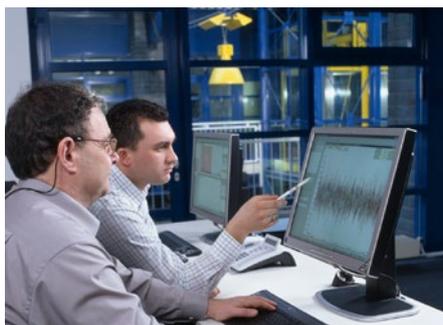
Analysis of measured data done by Schaeffler
