## Schaeffler Global Technology Solutions

### Thermographic Examination Of Cabinets

The customer is one of the leading Spanish manufacturers of heat and cold formed welded steel piping and hot strip. Its annual production amounts to 130 000 tons of 3/8 inch to 4 inch piping, nearly half of which is exported.

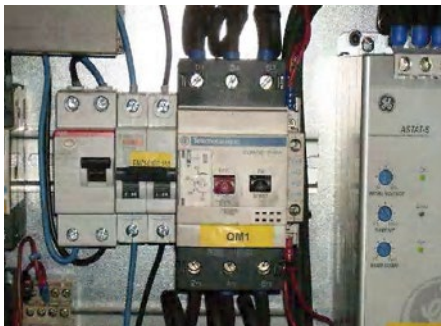
Low voltage cabinet

##### Low voltage cabinets:

- Saw switchboards
- Blower switchboards
- Welding machines switchboards
- Lighting switchboards

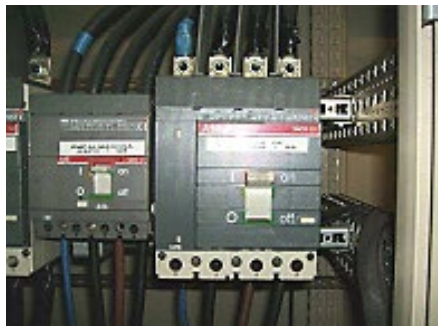
Low voltage cabinet
