Schaeffler Global Technology Solutions

Steel and non-ferrous metals

Increased Gearbox Availability in a Welded Steel Plant

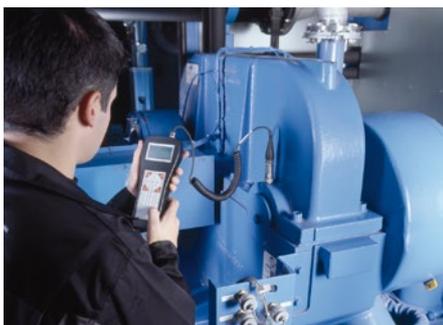
Condition monitoring measurement

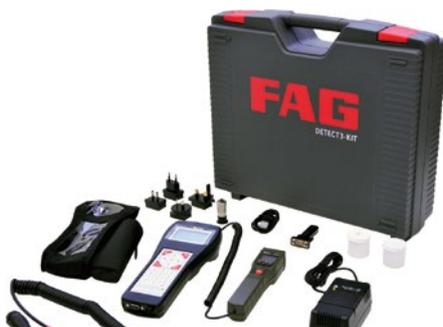
FAG Detector III

FAG Detector III functions used by the customer:

- Monitoring functions:
 - ISO 10816
 - Frequency selective condition monitoring of rolling bearings
 - Gearbox condition
 - Rolling bearing condition
- Measuring routes
- In-depth diagnosis on the basis of time signals and frequency spectra
- Free PC software

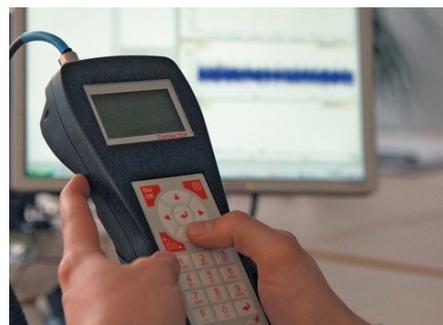
Data transfer to the PC
