Schaeffler Global Technology Solutions

ThyssenKrupp Steel Europe AG, Germany

Condition Monitoring on a Hot Strip Mill

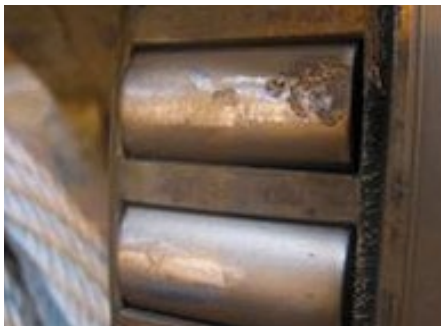
Damage to rolling element of tapered roller bearing

Following the installation of seven FAG DTECT X1 online condition monitoring systems the work rollers are permanently monitored. The vibrations sensors were integrated in the customer's software and the customer's staff trained to independently operate the condition monitoring system. Schaeffler has access to the TKSE intranet by means of remote software, allowing the vibration experts to evaluate the data in the Schaeffler Online Monitoring Center. One case of bearing damage was immediately detected during test measurements for sensor installation.

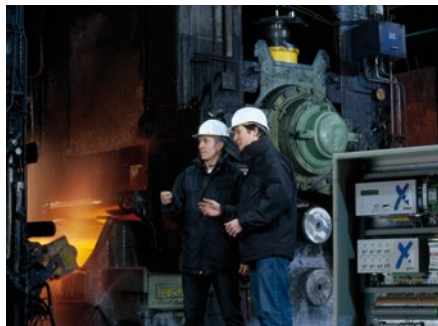
Condition monitoring with FAG DTECT X1

7 x 2 channel FAG DTECT X1

- 14 ICP acceleration sensors
- 2 sensors per stand at the level of the operating side of the work roller roll chocks

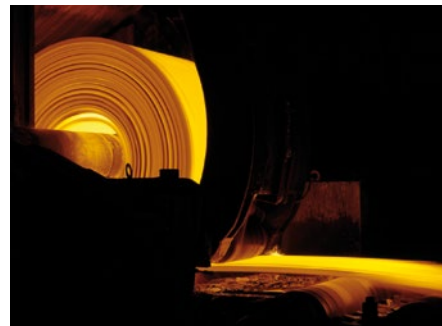
Hot strip mill in steel production
