## Schaeffler Global Technology Solutions

### Mounting Service at a Wire Mill reduces Downtime Costs

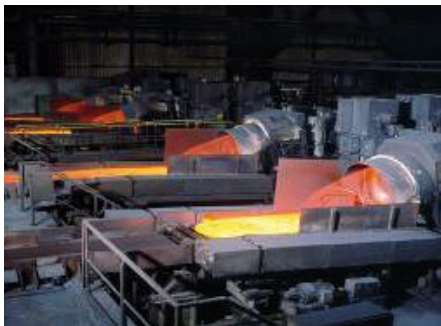
Laying head at wire mill

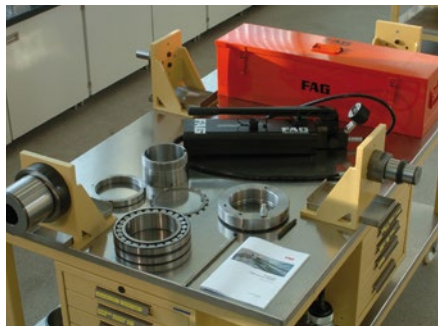
Expert tools for mounting and dismounting

The very same day Schaeffler received the emergency call, an experienced mounting expert was sent to the customer. He had total flexibility with regard to time and work. So he could provide tailor-made support. The mounting expert detected that the bearings had failed due to wrong mounting. Additionally he supervised the professional fitting of the new bearings. Besides providing this first aid, Schaeffler also conducted a practical training course with the customer's staff which comprised proper mounting using the right mounting tools.

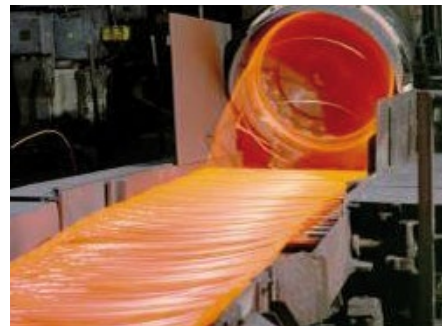
The red hot wire is put into shape
