## Schaeffler Global Technology Solutions

### Trouble-shooting Measurements in 4-High Cold Rolling Mill

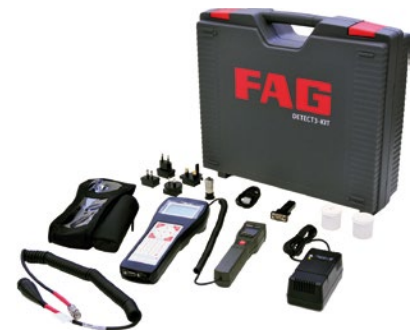
Vibration measuring device FAG Detector III

- Modal analysis
- Operating vibration measurement
- Bump test
- Run up / coast down measurements
