Schaeffler Global Technology Solutions

Steel and non-ferrous metals

Condition Monitoring of Saw Gearboxes Increases Availability

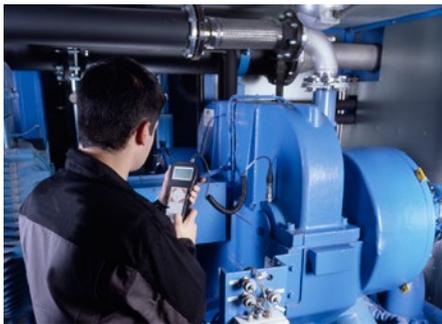
Measurements with FAG Detector III

To get a better understanding of the saw's gearbox condition, Schaeffler Iberia recommended the customer to monitor the equipment with a condition monitoring device. Schaeffler experts presented the FAG Detector III to the customer, created measuring routes and trained the maintenance staff. The FAG Detector III is an offline vibration measuring device able to measure machine vibrations on predetermined measuring points. By calculating characteristic values it provides important machine information. These helped the customer to ensure that line 1 operated without failures until the next planned downtime and line 2 until the receipt of a required replacement part.

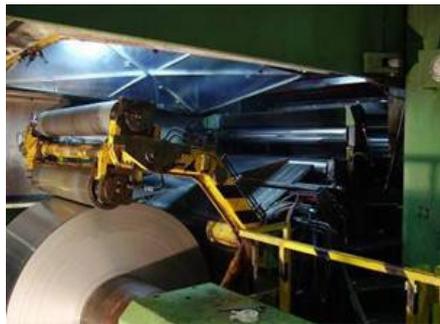
Tape for the production of welded tubes

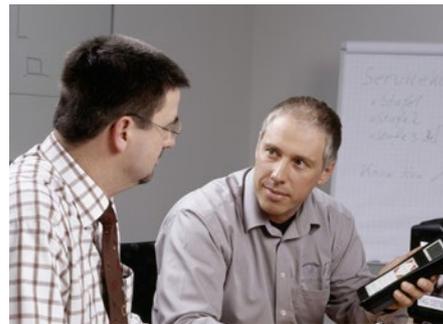
FAG Detector III training
