## Schaeffler Global Technology Solutions

#### Oerlikon Barmag, China

#### Friction Disk Spindle Bearing Failure Analysis

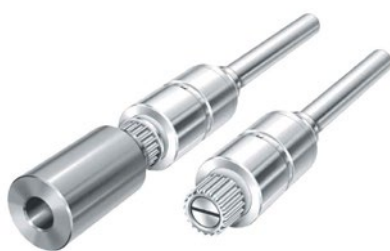
INA-brand friction unit spindle F-221502.06 & F-220501.06

INA-brand friction unit bearing F-221502.06
