Customer
Success
Story

Thermographic examination of cabinets

Steel manufacturer, Spain

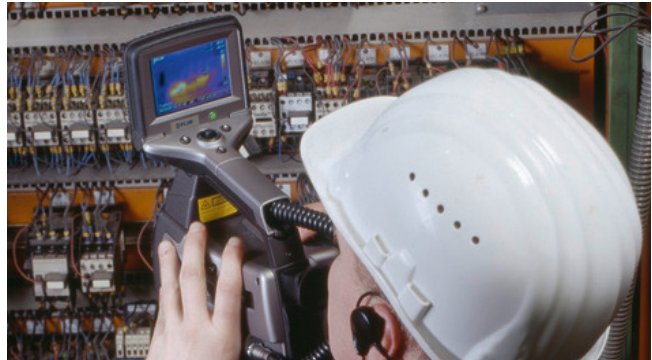
Switchgear is examined with a thermal imaging camera

The experts of Schaeffler Iberia carried out thermographic measurements on different low voltage cabinets. The aim was to locate the hot areas that had caused the unplanned downtimes without the regular examinations and adjustments and without reducing the machine's availability.
