# Defect detection with OPTIME

## Reliable machine monitoring around the clock

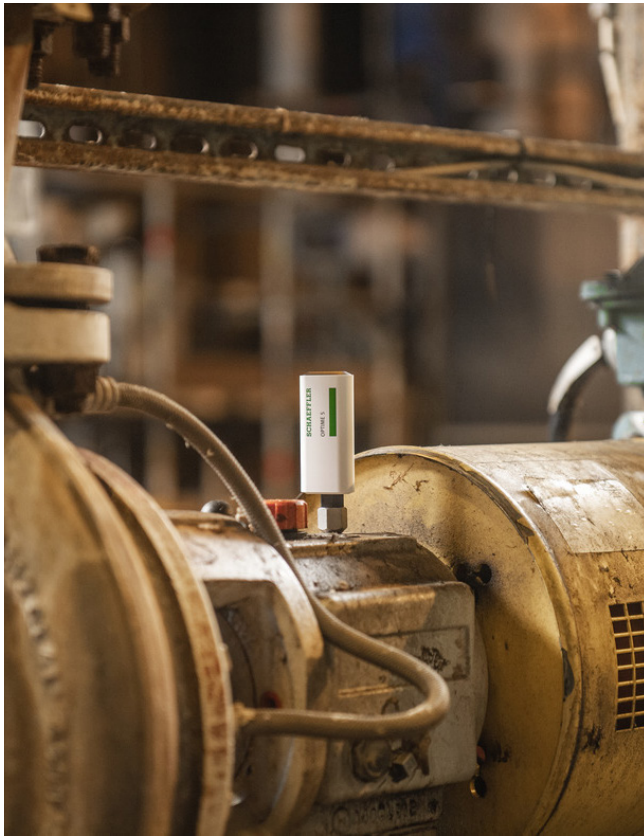
OPTIME sensor on a pump

After several months of normal operation, the sensors detected a start-up error. The machine status changed from *Normal* (level 1\*) to *Warning* (level 3\*) within two days.

The customer's maintenance team confirmed the failure and immediately replaced the pump. Had the milling cutter failed because of the defective pump, the production line would have to be stopped, leading to considerable material waste.

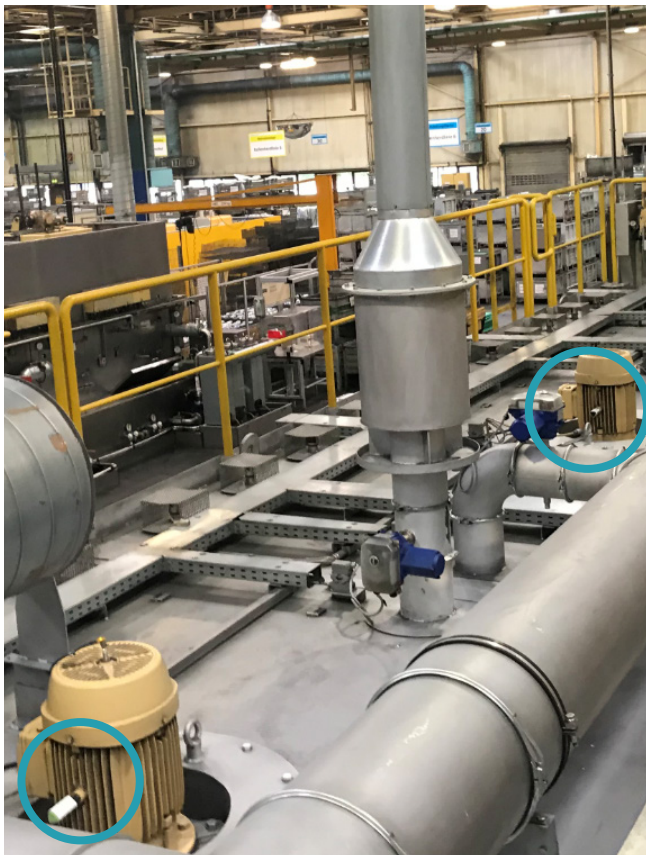
OPTIME sensors on motors

The sensors triggered several alarms and indicated that the ISO level had clearly exceeded the main limit value in the motor. A manual check revealed that the motor already had an imbalance, and probably bearing damage before the sensor was installed.

The customer's maintenance team confirmed the failure. The motor was replaced. Had the defect not been recognized in time, part of the production line would have failed.

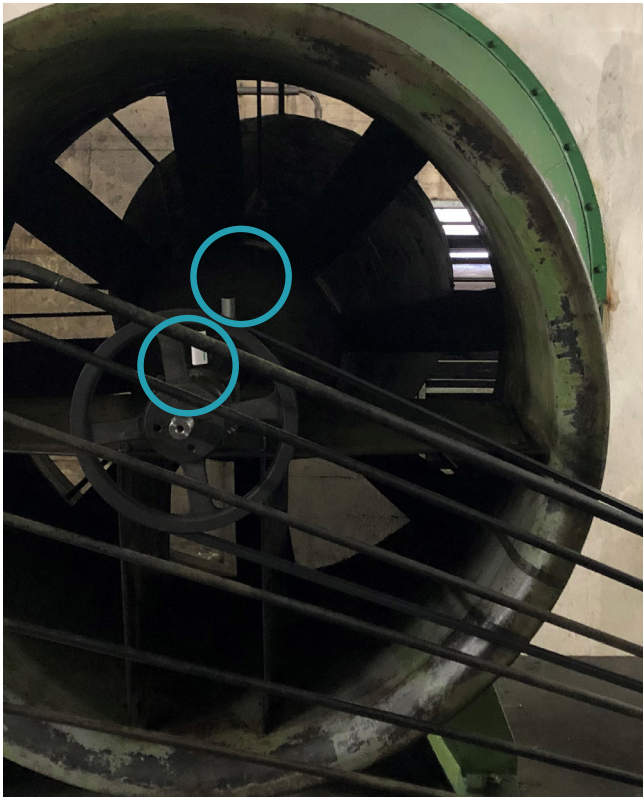
Fan system

OPTIME triggered a change in the machine status to *Suspicious* (level 2) and provided several individual alarms for trends.

The customer's maintenance team confirmed the accumulation of dirt on the blades of the dust filter fan and performed the cleaning process several times based on the measured vibration amplitudes in OPTIME.

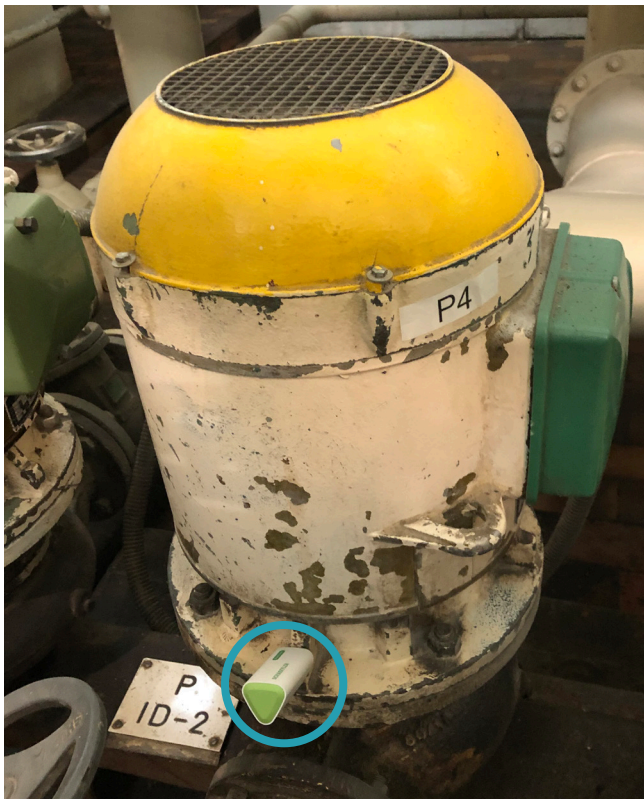
Filtration pump

After the filtration pump failed unexpectedly in the customer's wash press, OPTIME increased the machine status warning to level 3\*. Imbalance or a misalignment was considered the probable cause.

The customer's maintenance team confirmed the total failure of the clutch and replaced the entire unit.

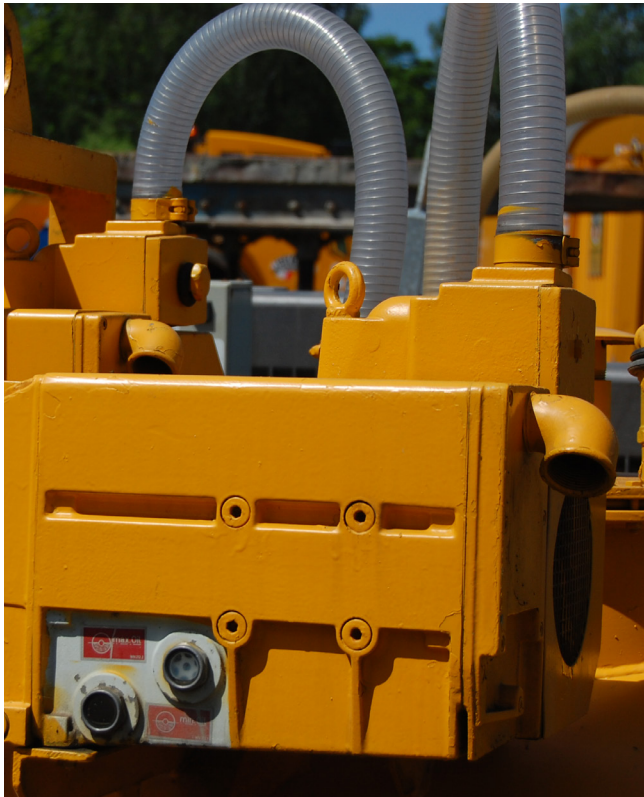
Vacuum pump

Immediately after the installation of OPTIME, the sensor on the vacuum pump motor issued an alarm notification concerning the measurement of the ISO vibration intensity. The sensor achieved this despite still operating in its learning phase.

The customer's maintenance team confirmed during the next planned shutdown, that the motor had indeed suffered bearing damage.

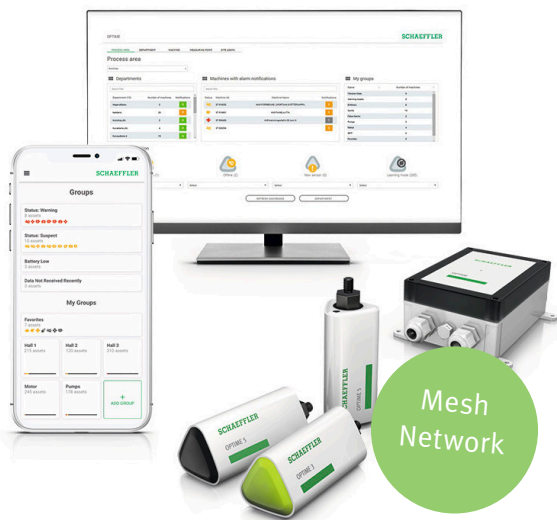
OPTIME - Plug. Play. Predict.

OPTIME from Schaeffler allows for comprehensive condition monitoring that is both easy and affordable. Thanks to its simple plug & play installation, OPTIME allows you to start monitoring hundreds of rotating machines in just a few hours.

Vibration bandwidth	OPTIME-3: 2 Hz – 3 kHz OPTIME-5: 2 Hz – 5 kHz
Calculated parameters	7
Sensor commissioning	NFC (Near Field Communication)
Communication	Wirepas Mesh (2.4 GHz ISM band)
Measurement cycle	Parameters: every 4 h Time signal: every 24 h
