Service Info

Change of design to protective dust cover

Part replacement - RIU: 566283.H195 replaced with 566283.01.H195

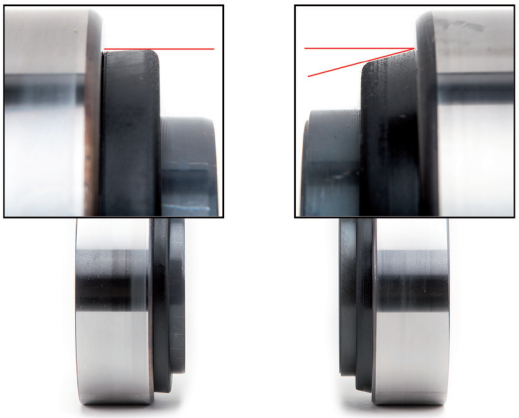
During fitment of Repair Insert Unit (RIU) part number 566283.H195, the protective dust cover may become twisted on some wheel hubs.
In the worst case scenario, a twisted protective dust cover may cause a bearing to become obstructed, thereby making it difficult for the wheel hub to turn or prevent it from turning altogether.

Image 1: The design of the dust-protection cover has been changed

Image 2: New version (566283.01.H195)

For this reason, a modified protective dust cover has been developed (see image 1).

As a result of this technical modification, part number 566283.H195 has been replaced with 566283.01.H195.
